BUILDING SCIENCE SERIES 40

Engineering Aspects of the 1971 San Fernando Earthquake

This report presents the observations of the NBS on-site inspection team (most photographs in this report were taken by the team). The material presented herein is intended to serve as (1) a documentation of damage resulting from the earthquake and (2) as a source document for further studies, research, and recommendations. This is particularly important as necessary remedial work and restoration have resulted in the removal of evidence that is essential for studies and evaluations.

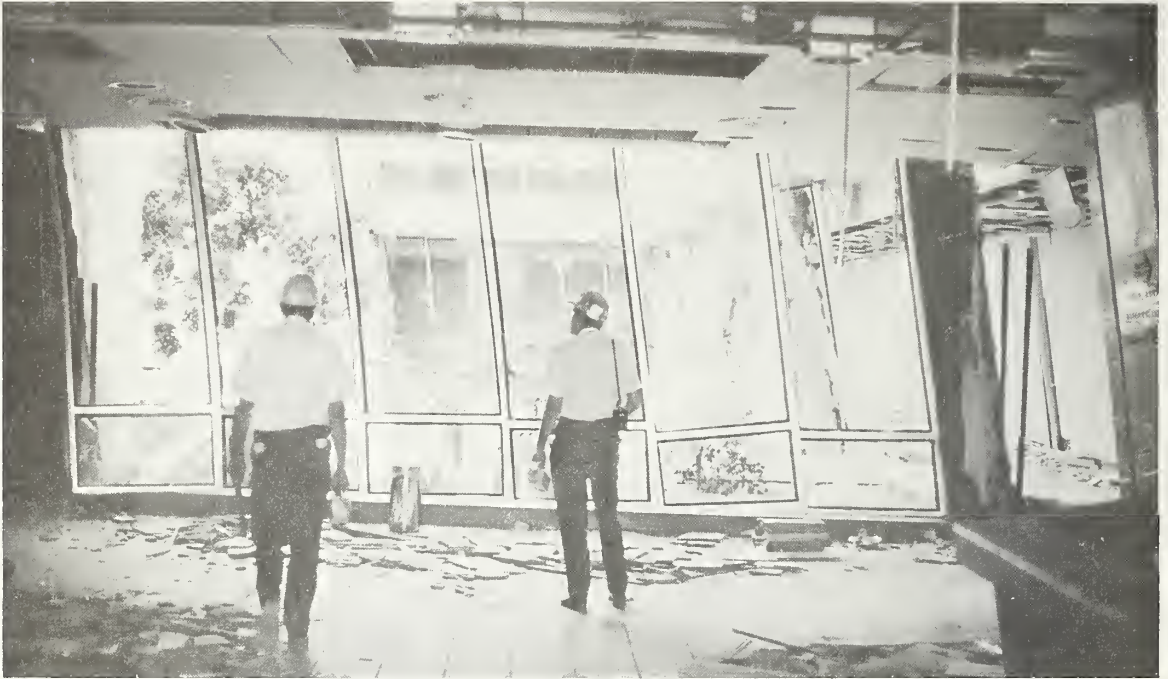
Figure 5.28 Damaged main lobby in Wing A. Note the window mullion distortion. The planted area seen through the window is a court enclosed by the four wings.

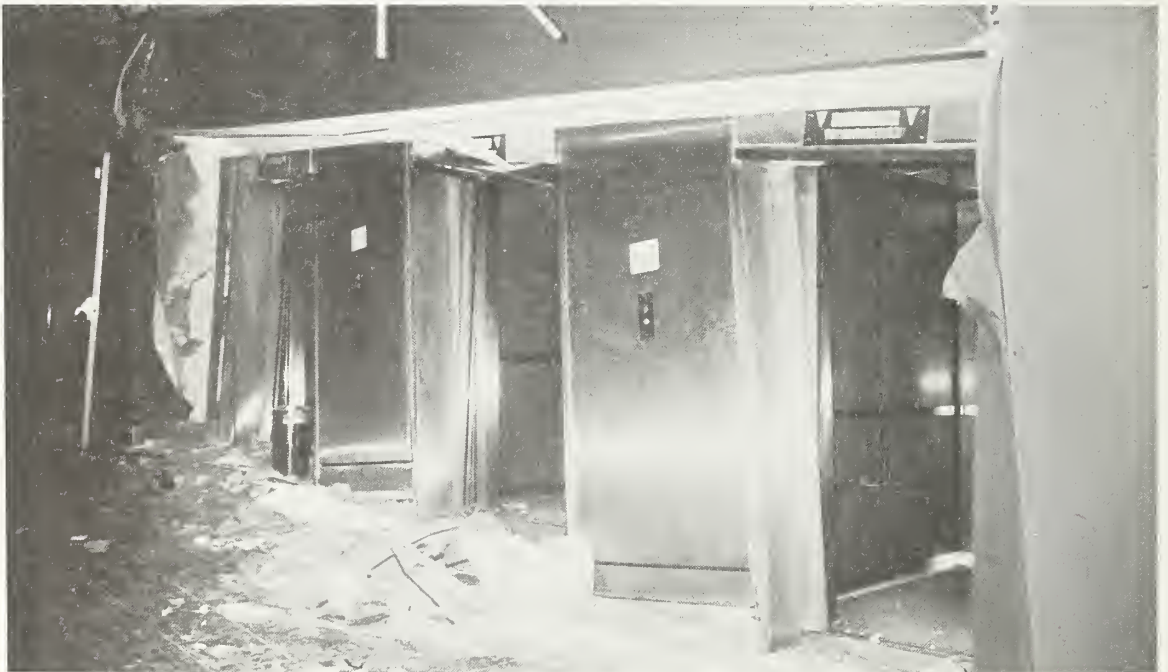
Figure 5.29 Damaged elevators in the Wing A lobby.

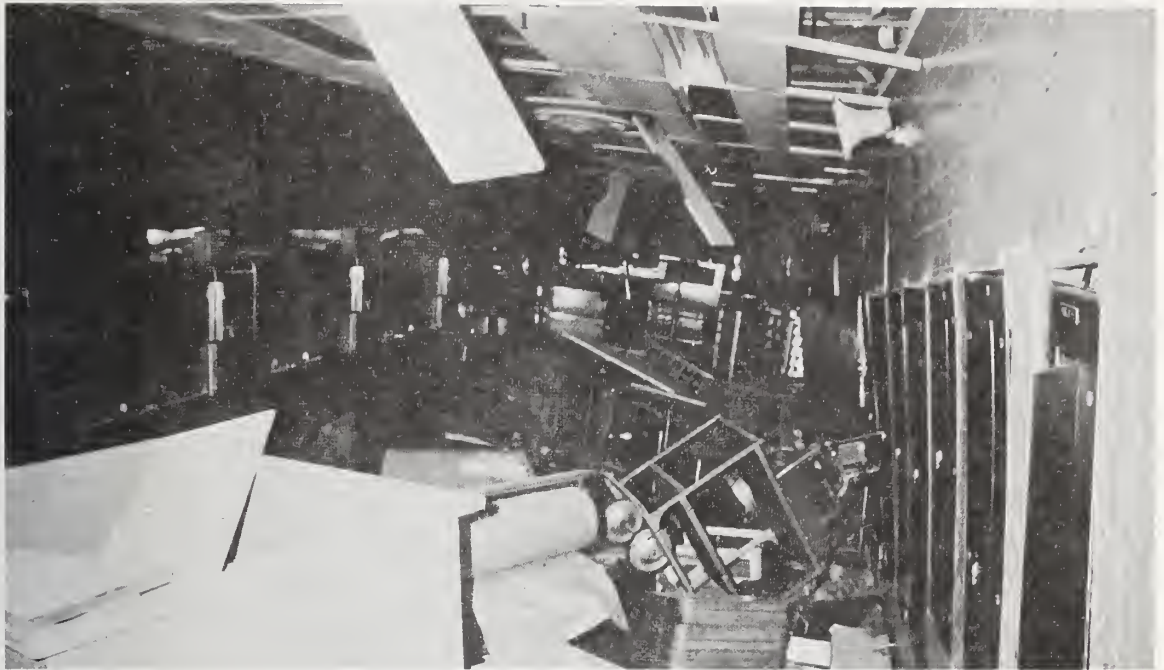
Figure 5.30 Violent shaking of the building left the ground floor hospital kitchen in shambles.

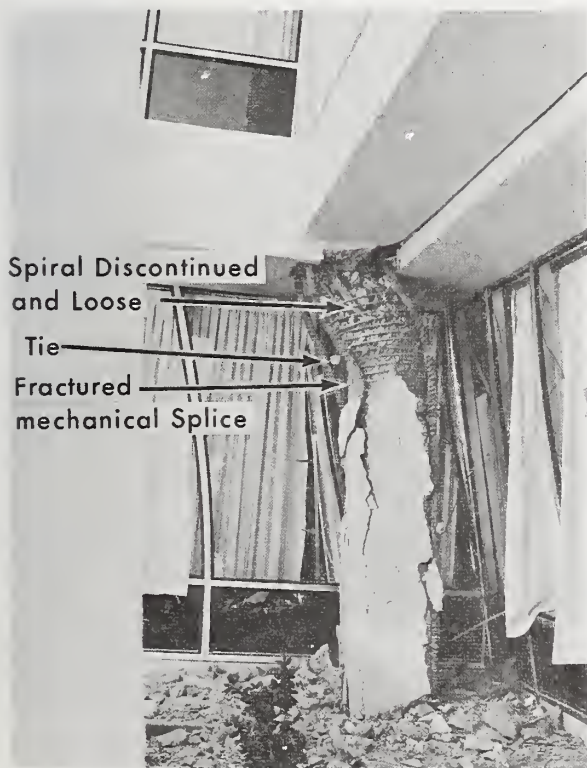
Several points are illustrated by the column shown in figure 5.31. A spiral column is basically more ductile than a tied column, but in lateral motion this ductility can only be achieved if ductility exists at the column-to-beam connection. In the connection shown, two things happened-

Figure 5.31 Damaged Spiral Column.

(1) the spiral stopped short of the connection, making it ineffective where it is needed most in lateral motion, (it should have been continued into the beam) and (2) the spiral unwound due to insufficient anchorage. Anchorage was intended to be achieved by lapping the spiral. This was not effective since the lap could not work once the covering concrete had broken away. Positive anchorage by hooks into the interior of the core is essential.

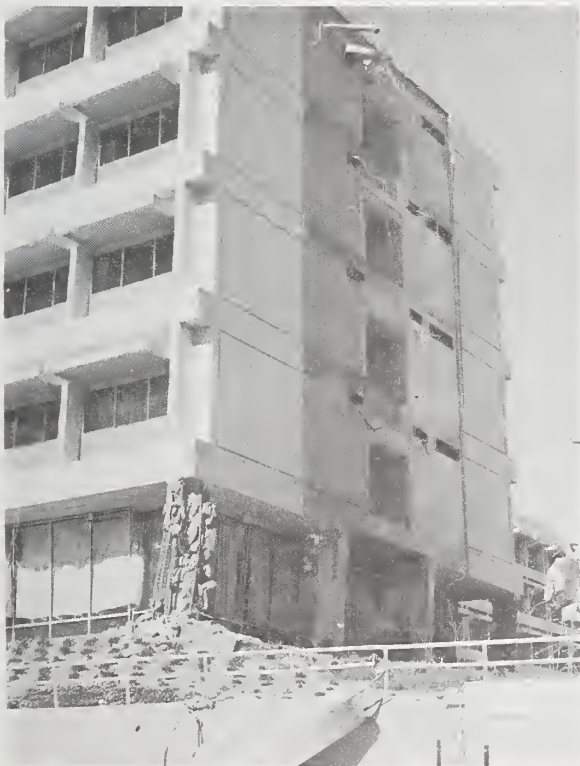
Stair towers A, B, and D overturned leaving the end of the wings exposed as shown in figure 5.33. Stair tower C, supported on footings, did not topple as is shown in figure 5.34. The overturning coefficient J was calculated as 0.557 and 0.656. Base shears were computed as 0.053 and 0.058 of the structure weight. Applying the J factor to the base shears means that the structure was designed for approximately 0.03 gravity when calculating overturning moment. All evidence indicates that accelerations at Olive View greatly exceeded this amount.

Figure 5.33 Wing D after stair tower overturned.

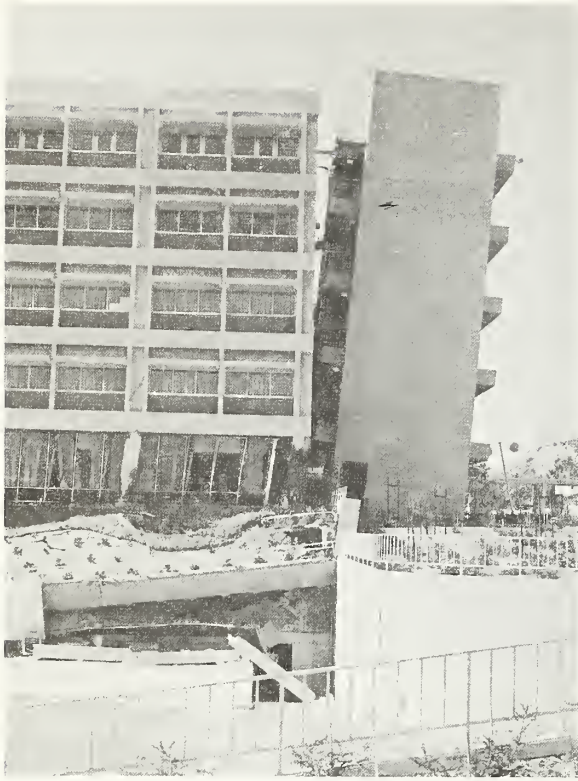
Figure 5.34 *Tipped stair tower at the end of Wing C. This is the only stair tower that did not topple. This stair tower is supported directly on the foundation; whereas, the other three towers were supported on the ground-story columns.*

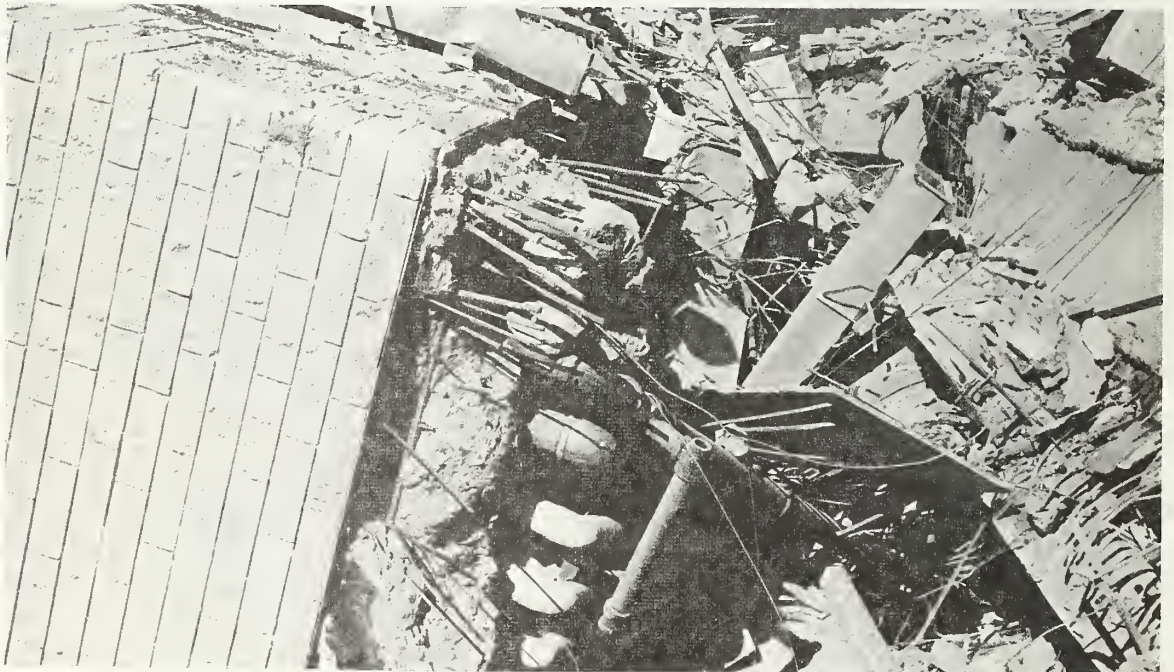
Examination of the base of stair tower B indicates bars which seemed to pull out of the first-floor slab (fig. 5.35). As previously indicated the stair tower walls were dowelled into the slab, which in turn was dowelled into supporting beams. These dowels were 36 in long (18 in into the walls and 18 in into the beams). The dowels matched the wall reinforcement which was usually No. 4 bars. This means that the overturning moment was resisted by No. 4 bars embedded 18 in. This is not adequate anchorage for such an important tensile tie under these load conditions.

Figure 5.35 *Base of stair tower B.*

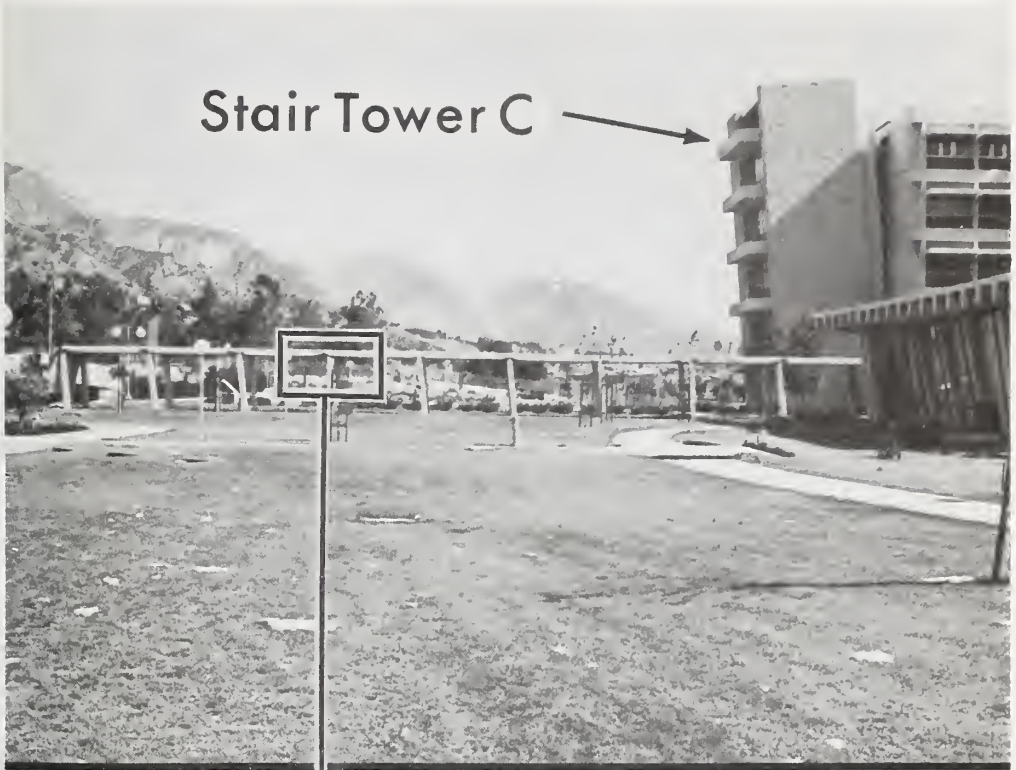
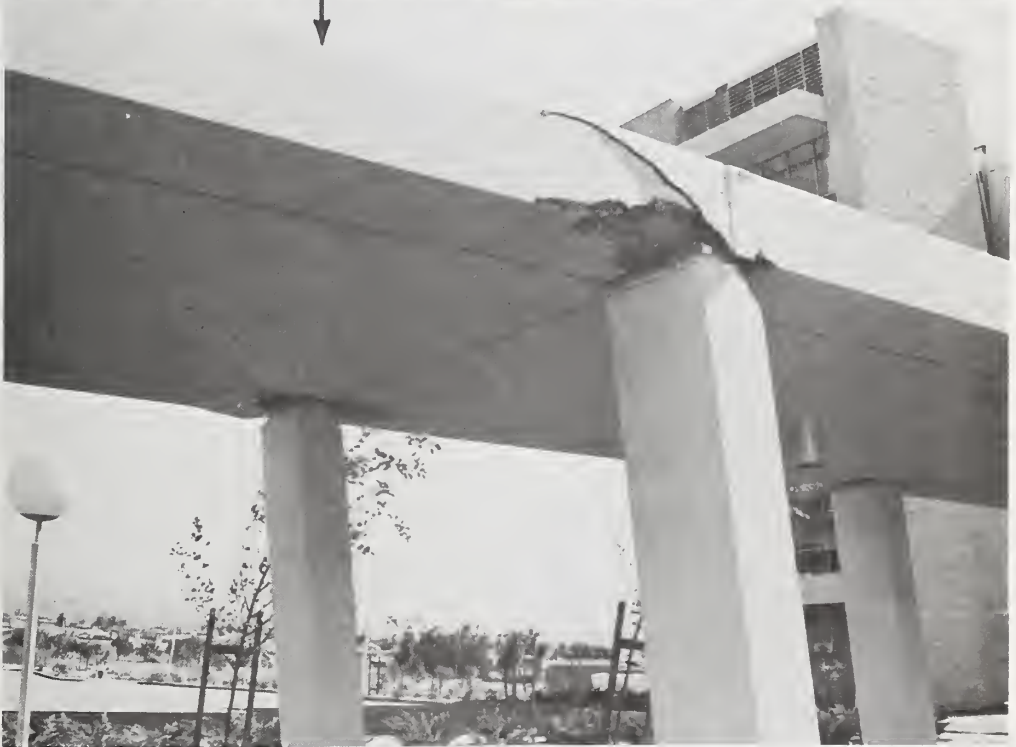
Canopy from Main Building to Psychiatric Unit - The canopy connecting the main building to the psychiatric unit is shown in figure 5.36; this structure was severely damaged. The canopy roof was of lightweight concrete, supported on a pair of stone aggregate concrete columns spaced 9.5 ft across the width. This pair of columns was spaced at 15 ft along the canopy length except near the assembly building. In the latter location the spacing varied. The column

Figure 5.36 Walkway Canopy.

reinforcing bars extended only a few inches into the canopy slab and could not offer restraint due to bending at the top of the columns.

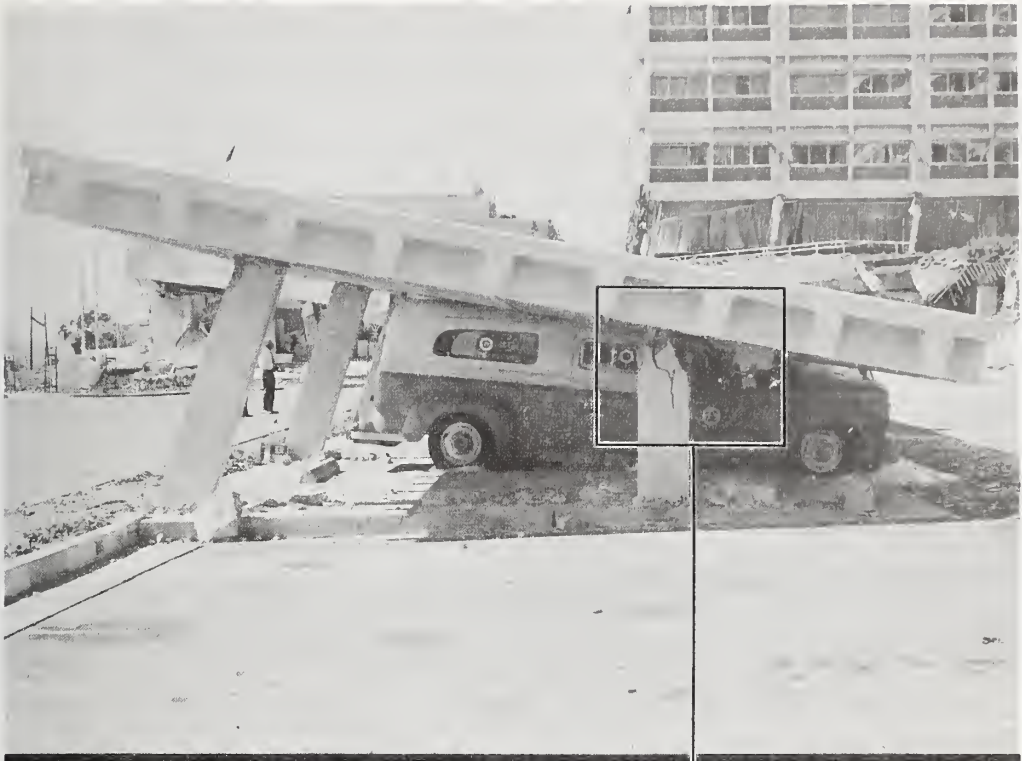
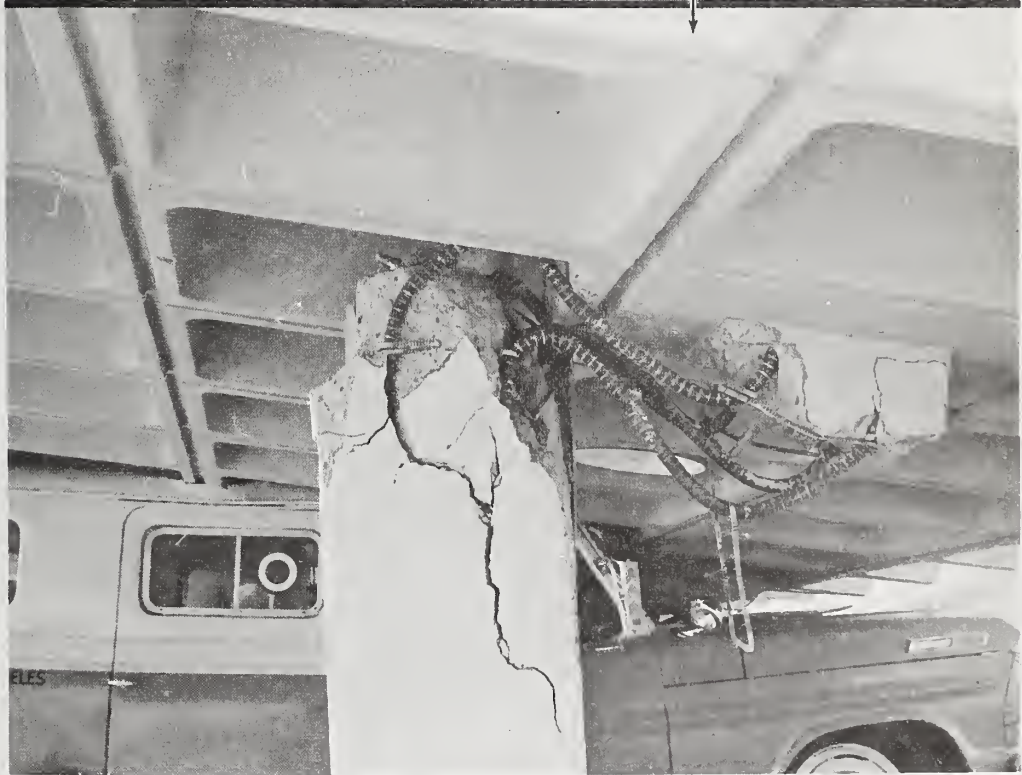
The columns failed as shown in figure 5.39. The north columns were restrained at the base by the pavement and tried to resist most of the shear. Note the nonshattered portion of the columns remained vertical. The south columns (originally vertical) rotated about the footings.

Figure 5.39 Damaged reinforced concrete ambulance port south of Wing D.

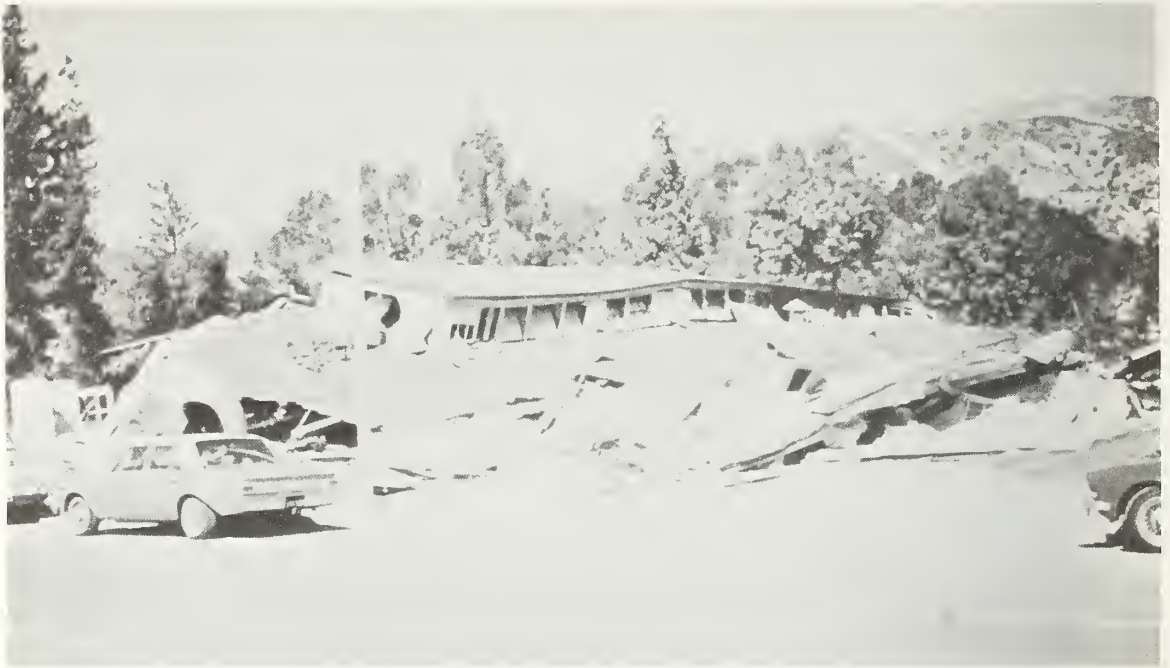
Old Buildings - There were a number of pre-1933 buildings in the old section of the Olive View complex. Many of these buildings were either totally collapsed or severely damaged. Figure 5.40a shows a completely collapsed old brick-wall building and figure 5.40b shows a severely damaged wood-frame house.

Figure 5.40a Totally collapsed old brick building at the old section of the Olive View Medical Center. The building was not designed to resist earthquake forces.

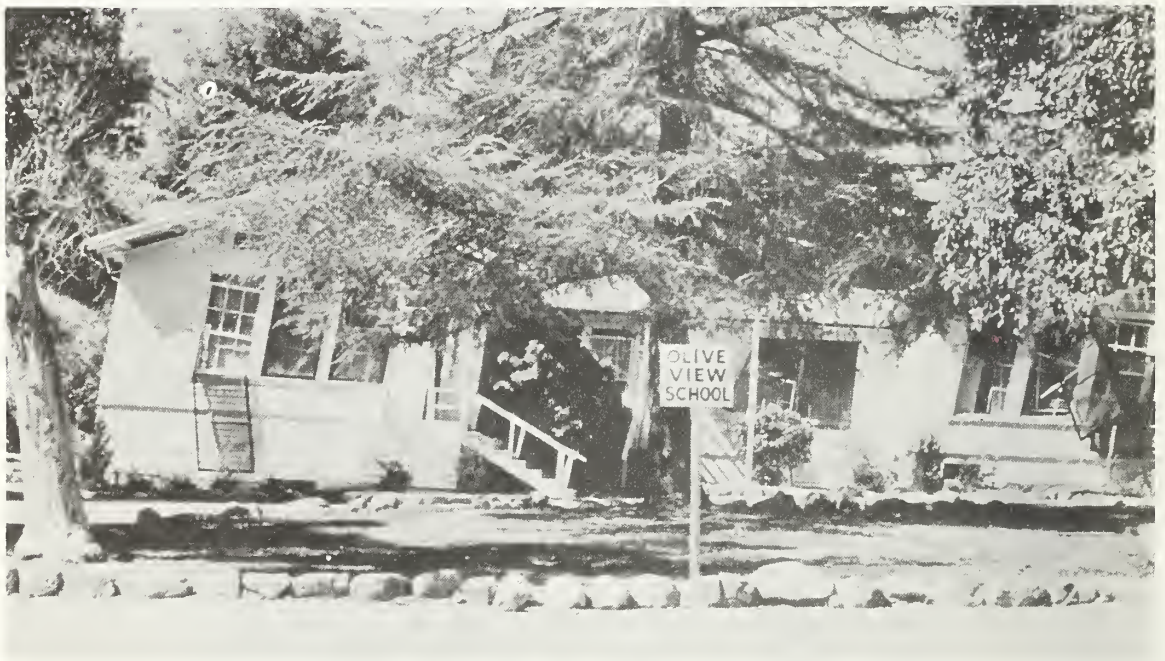
Figure 5.40b Severely damaged pre-1933 wood-frame structure at the old section of the Olive View Medical Center.

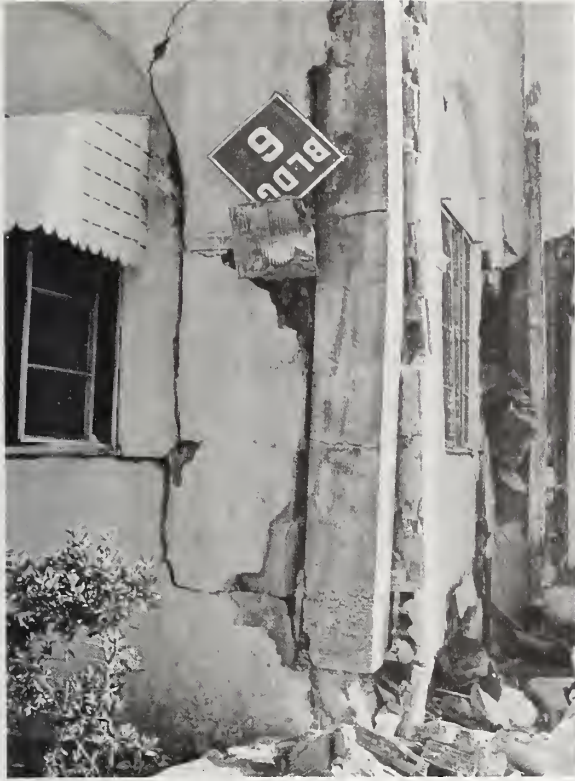
Building No. 6, a two-story building approximately 50 ft by 100 ft in plan, was one of the original 1925 buildings which was severely damaged (figs. 5.48, 5.49 and 5.50). A small one-story wood frame building (Building No. T-7) constructed in 1947 adjacent to Building No. 6 suffered no apparent damage.

Figure 5.49 Detailed view of one of damaged reinforced concrete columns. Exterior walls were unreinforced clay tile and stucco.

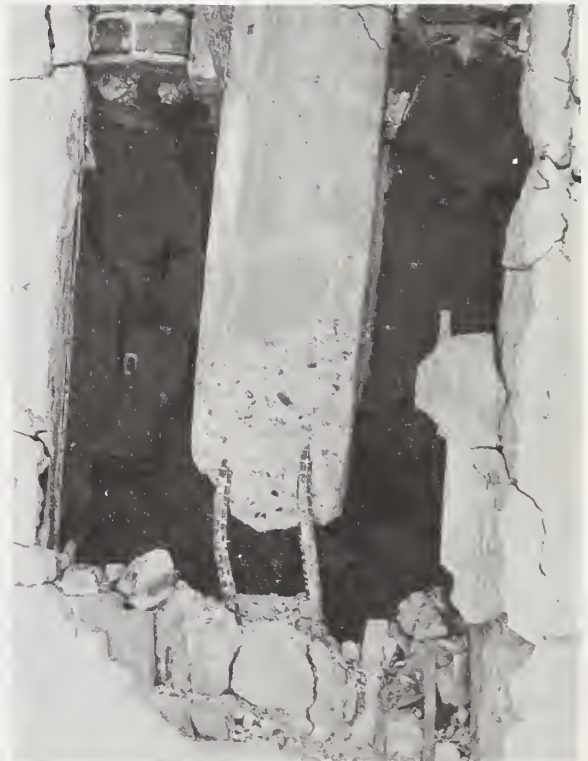
Figure 5.50 Close-up view of one of many damaged columns in Building 6. Note a lack of ties around the exposed square reinforcing bars.

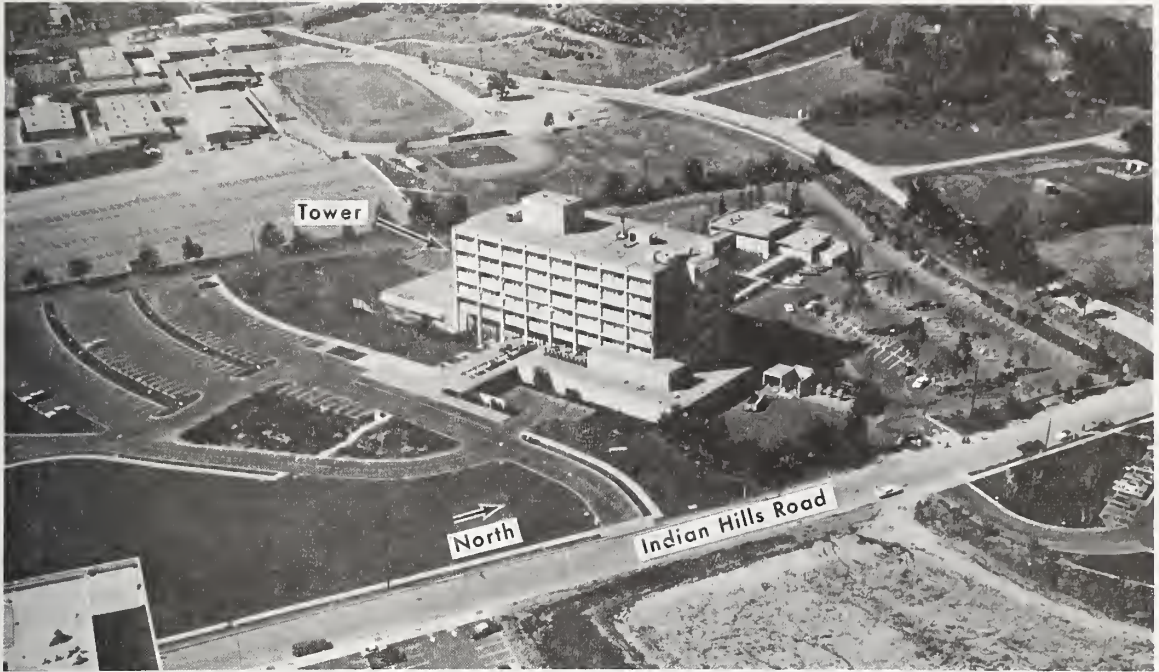
An aerial photo of the main building is shown in figure 5.56. The exterior columns on the north and south sides were extensively cracked, particularly in the third- and fourth-stories, as shown in figure 5.57. The concrete in the southeast fourth-story exterior column was crushed as shown in figure 5.58. Close-up views of this same column as viewed from inside are shown in figures 5.59 and 5.60 (note the splice of the column steel and the widely spaced ties).

Figure 5.56 Aerial view of Holy Cross Hospital. This 209-bed, reinforced concrete structure was badly damaged and has been evacuated.

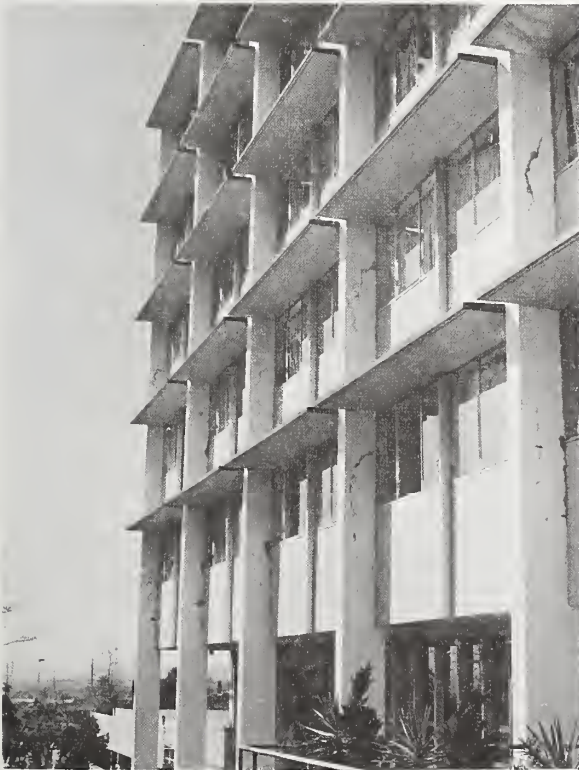
Figure 5.57 Extensive column cracking is visible in the third and fourth stories of the south face.

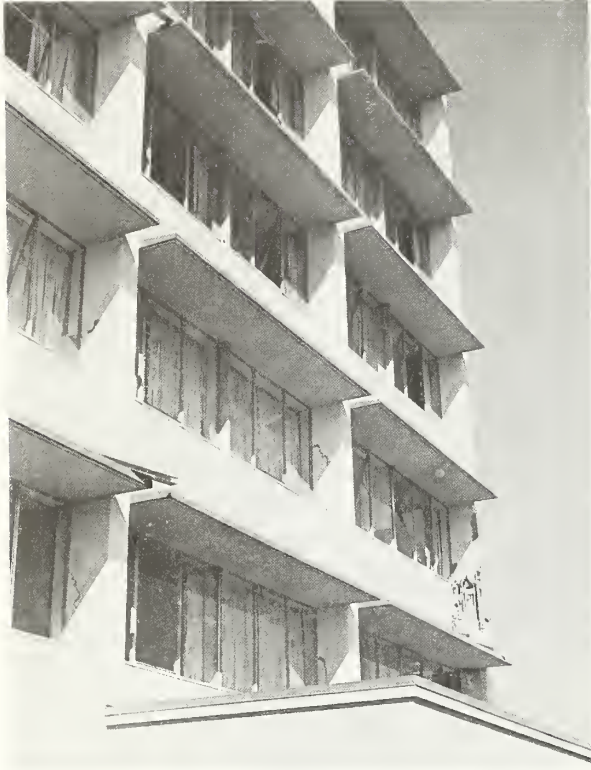
Figure 5.58 View of the failed column at the southeast corner of the fourth story.

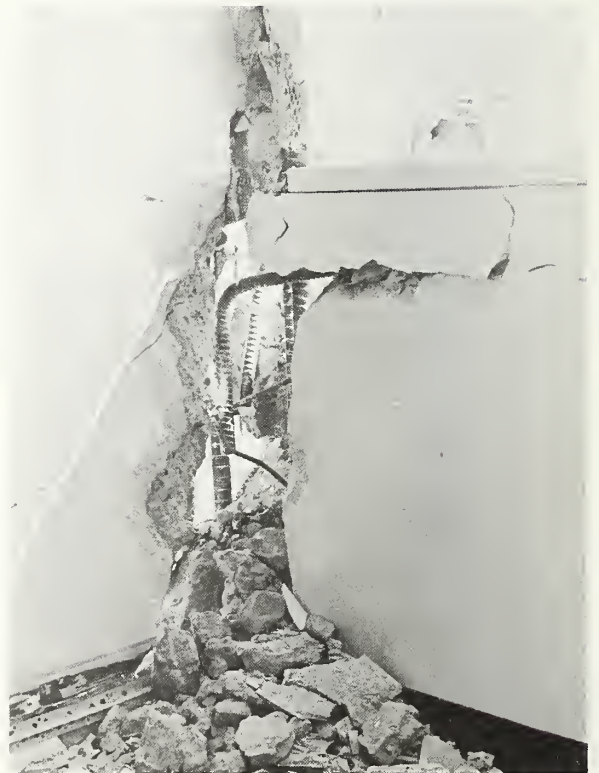
Figure 5.59 Damaged connection between the spandrel and shear wall on the southeast corner of the fourth floor.

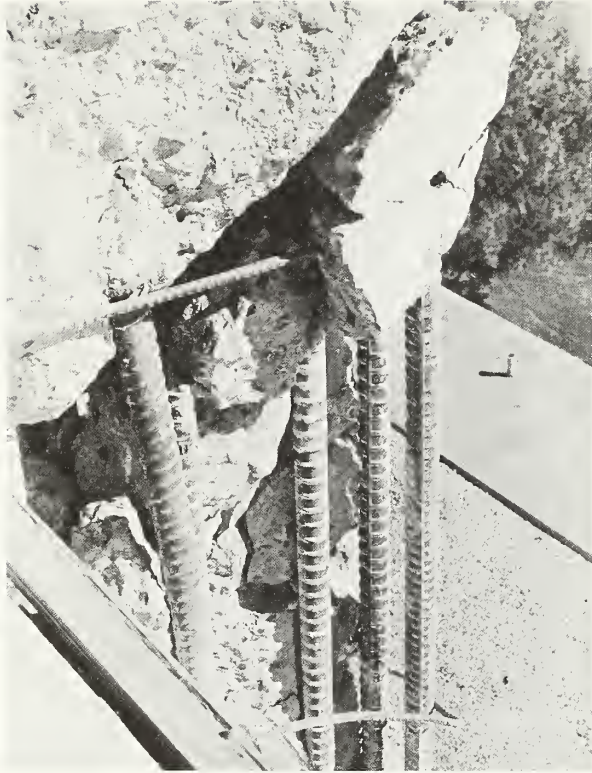
Figure 5.60 View of the reinforcement in the southeast corner fourth-floor column.

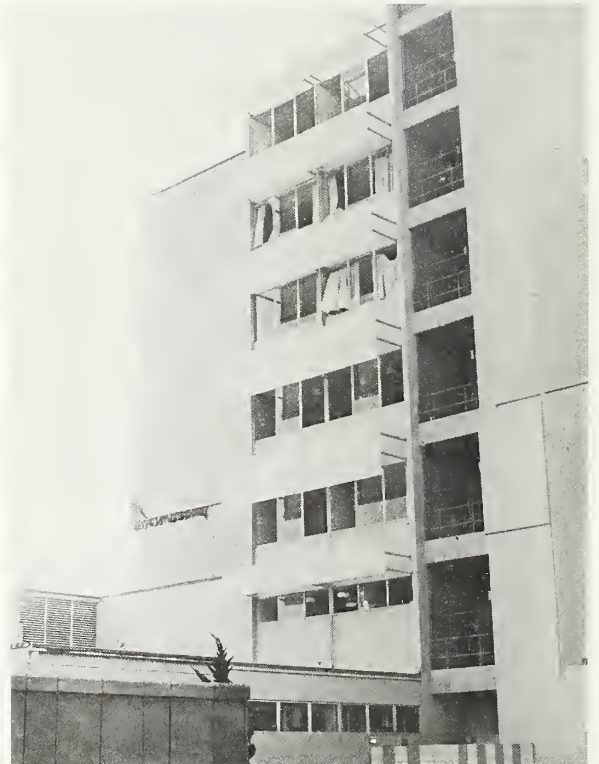
Further extent of damage at the fourth floor can be seen in figure 5.61. Note the massive failure at the fourth-floor construction joint.

Figure 5.61 East elevation of tower.

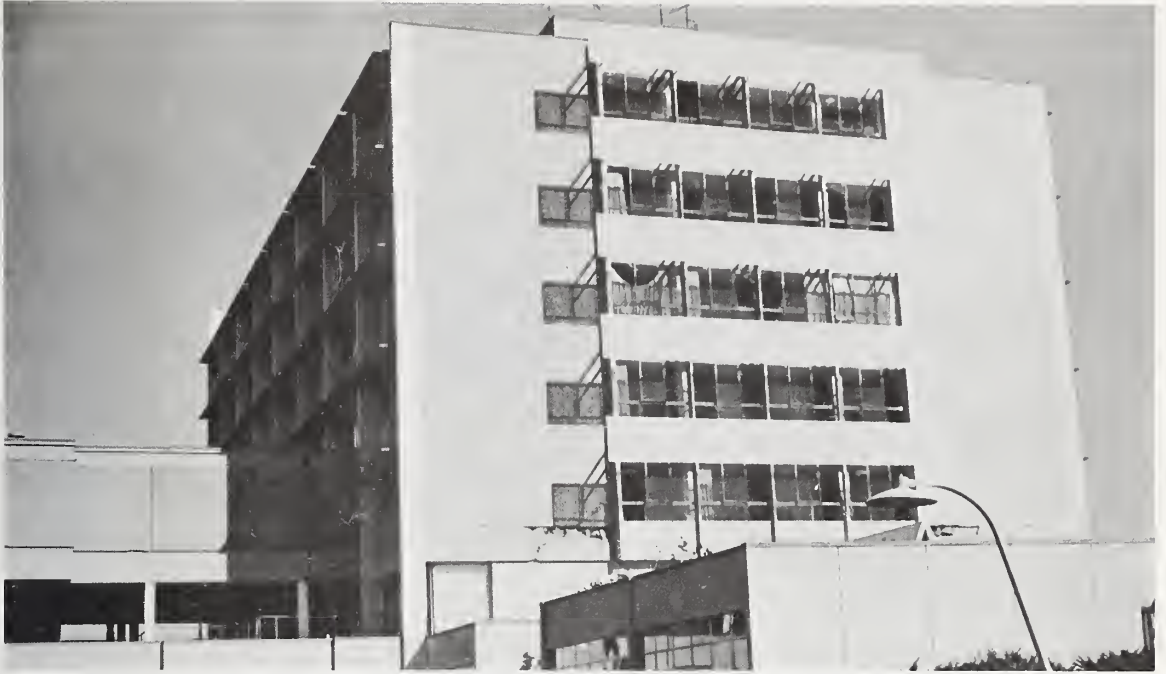
A west elevation of the tower is shown in figure 5.62. Note the horizontal cracking at the third-floor construction joint. A close-up of this damage is shown in figure 5.63. Interior damage was extensive at the west end of the third story. Two third-story columns centered between the two end walls failed in shear. The southernmost of these columns is shown in figure 5.64. The third floor in this area was extensively damaged as shown in figure 5.65 (note the base of one column in the background and the door off to the right). A closeup of floor displacement is shown in figure 5.66. The room located through the door to the right in figure 5.65 (northwest corner) is shown in figure 5.67. Note the cracks in the shear wall, floor, and spandrel. The southwest corner room is shown in figure 5.68. Damage was similar to that in the northwest corner room.

Figure 5.62 West elevation of tower.

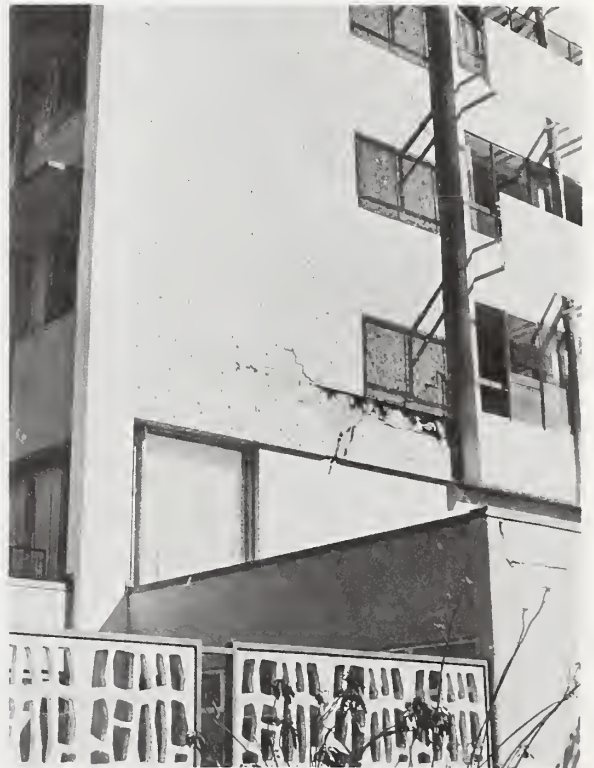
Figure 5.63 Failure at third-story construction joint at the west end of the tower.

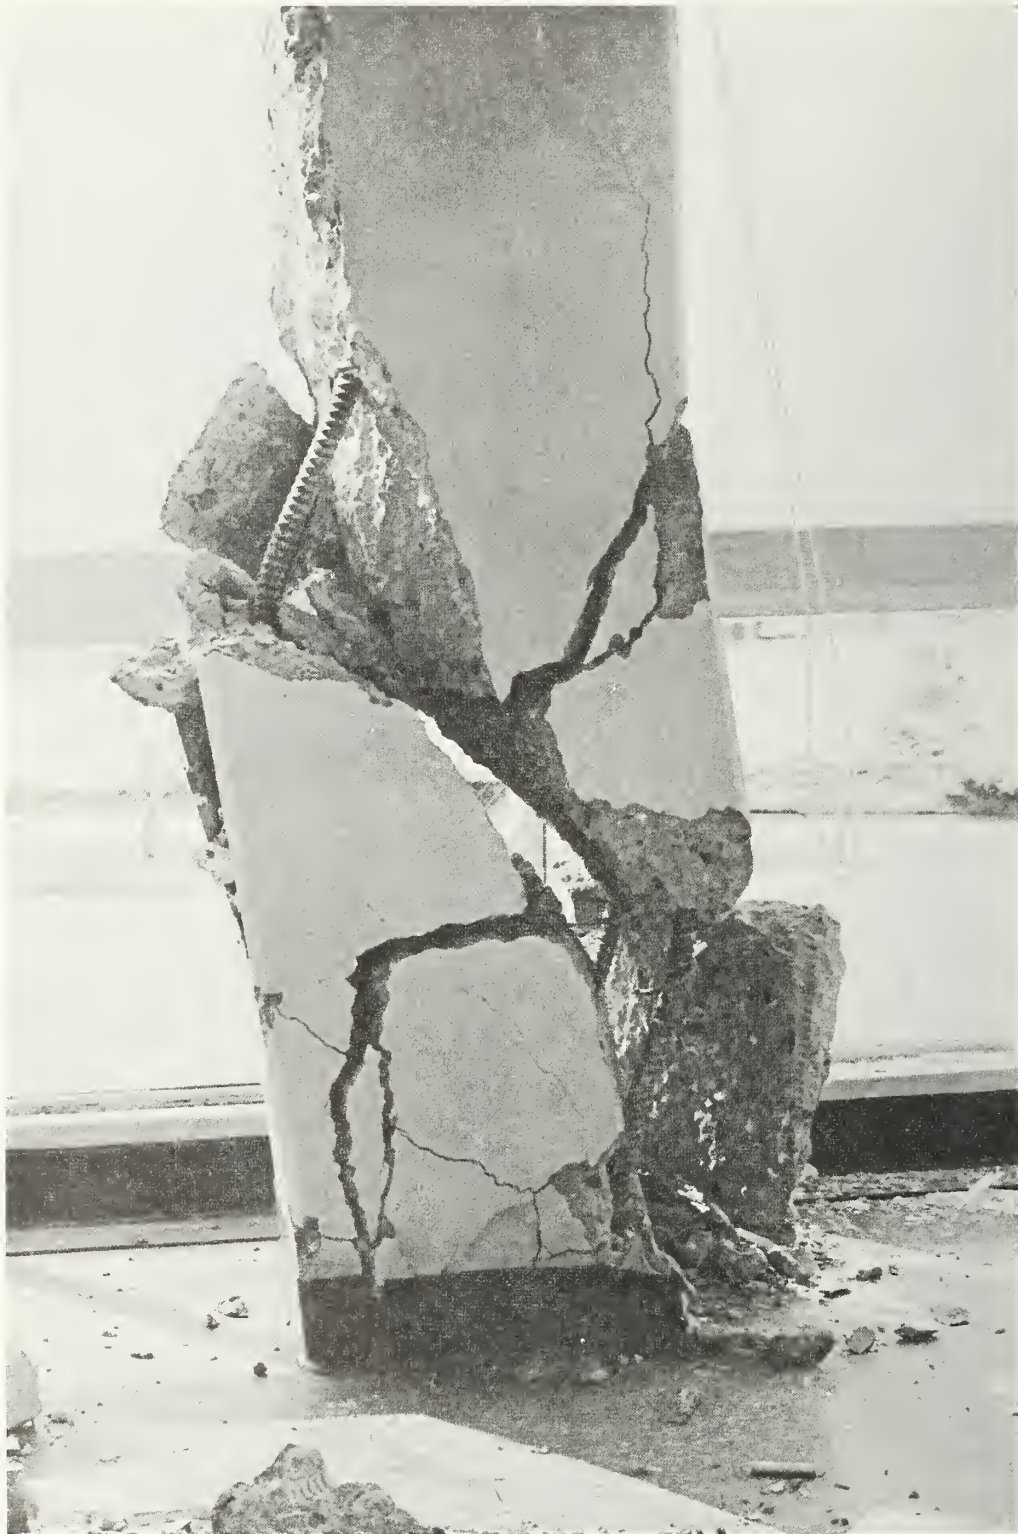
Figure 5.64 Reinforced concrete column at the west end of the third story.

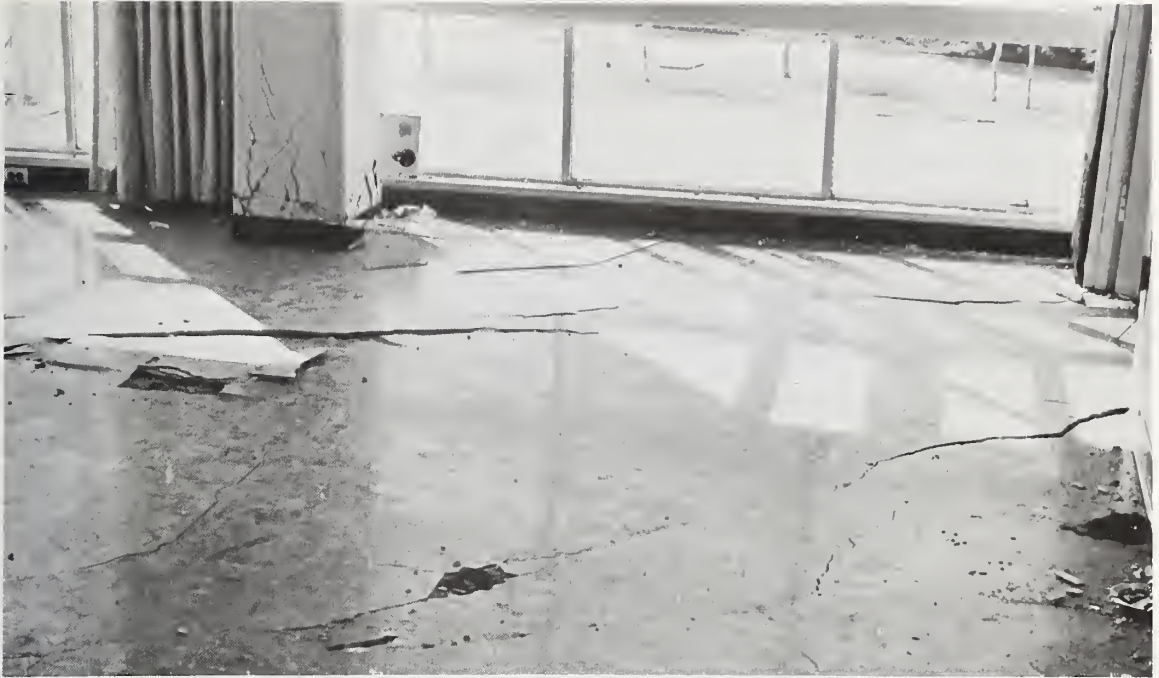
Figure 5.65 Floor damage at the west end of the third floor.

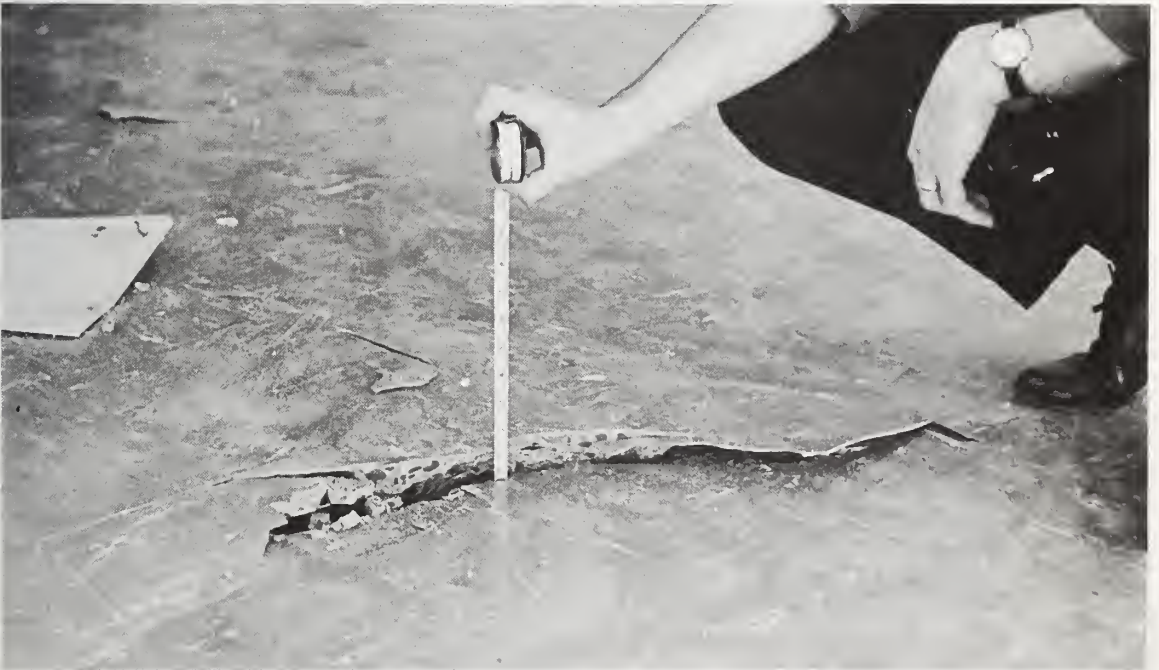
Figure 5.66 Floor cracking at the west end of the third floor. The floor is concrete pan-joist construction with a 3-in. slab.

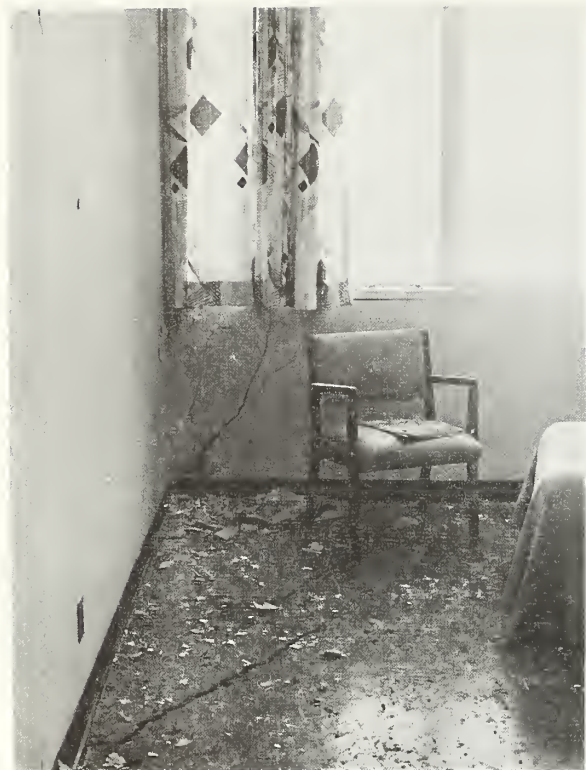
Figure 5.67 Damaged northwest corner room on the third floor. Note shear wall, floor, and spandrel cracking.

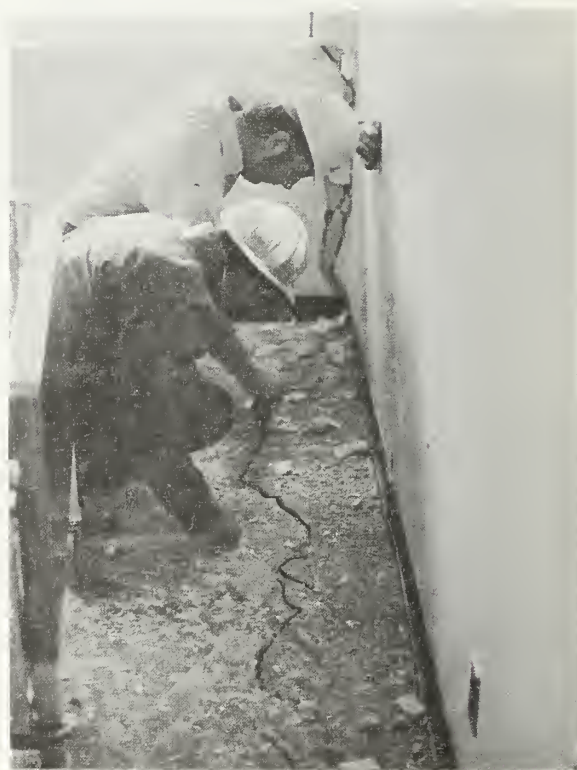
Figure 5.68 Damaged southwest corner room on the third floor. Note floor and spandrel cracking.

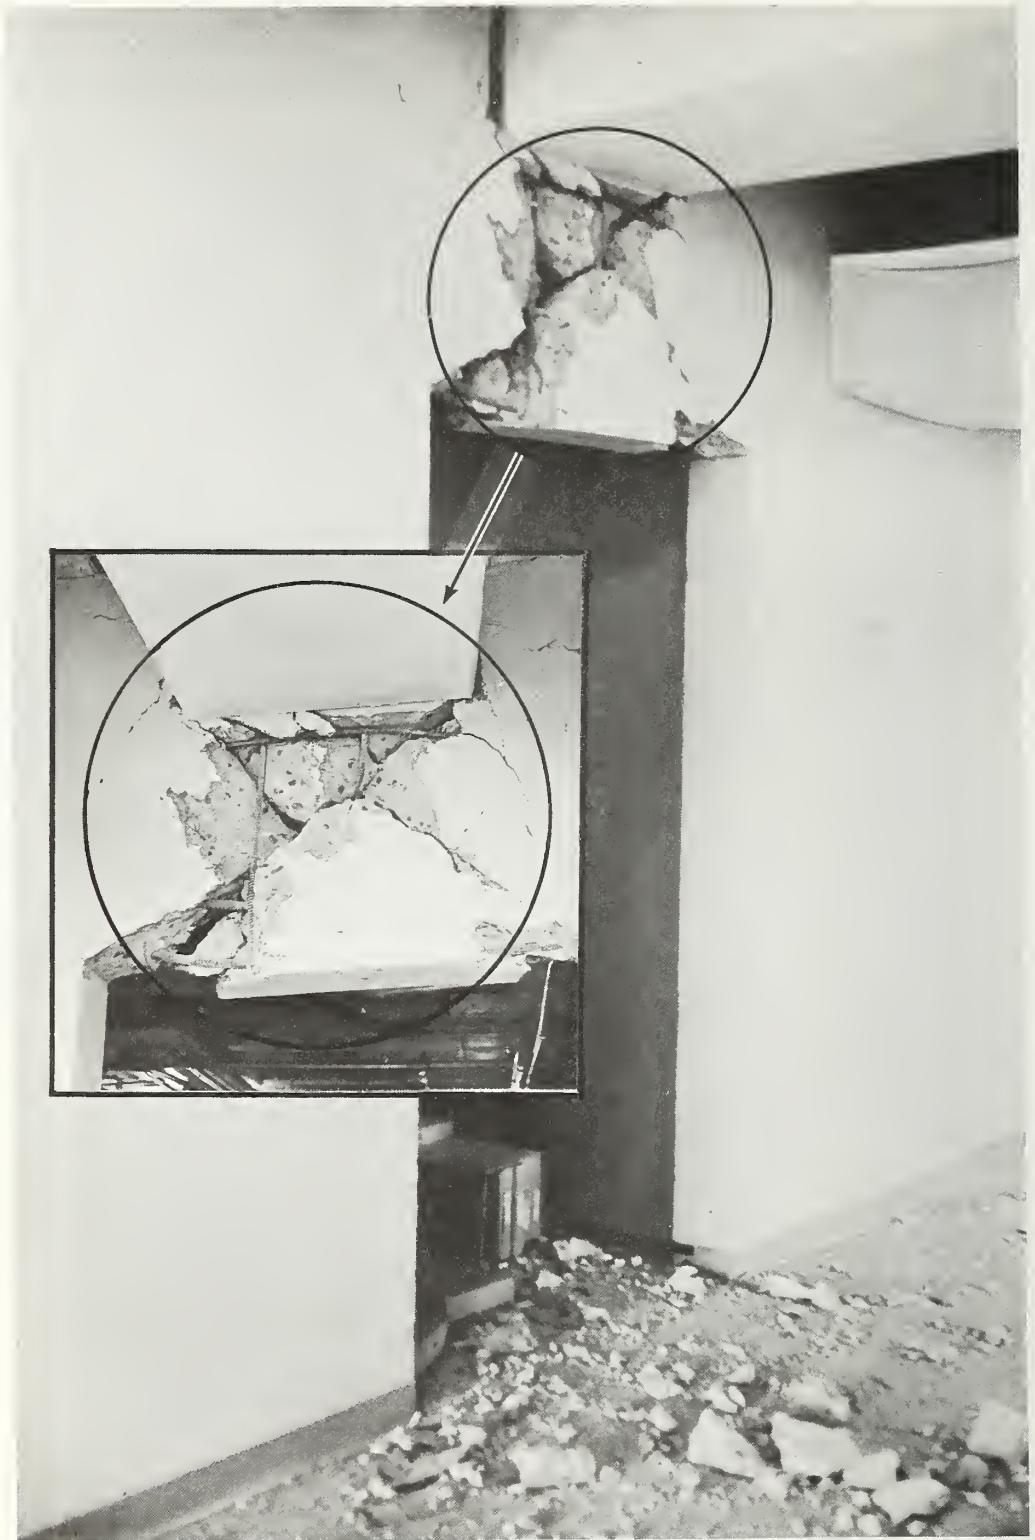
Limited wall cracking was found in the basement and more pronounced wall cracking was found in the first- and second-stories. Structural damage was not severe above the fourth story although some did occur as shown in the photograph of a doorway on the seventh story in figure 5.70. Shaking on the seventh floor also caused shelves to overturn, dumping their contents on the floor (figure 5.71).

Figure 5.70 Beam over doorway near the west end of the seventh floor. A duct passes through an opening above the beam.
